**ARBORIST REPORT**

**33 WATKINS ROAD  
ELEMORE VALE**

**SCOTT McDOUALL  
29/06/12**

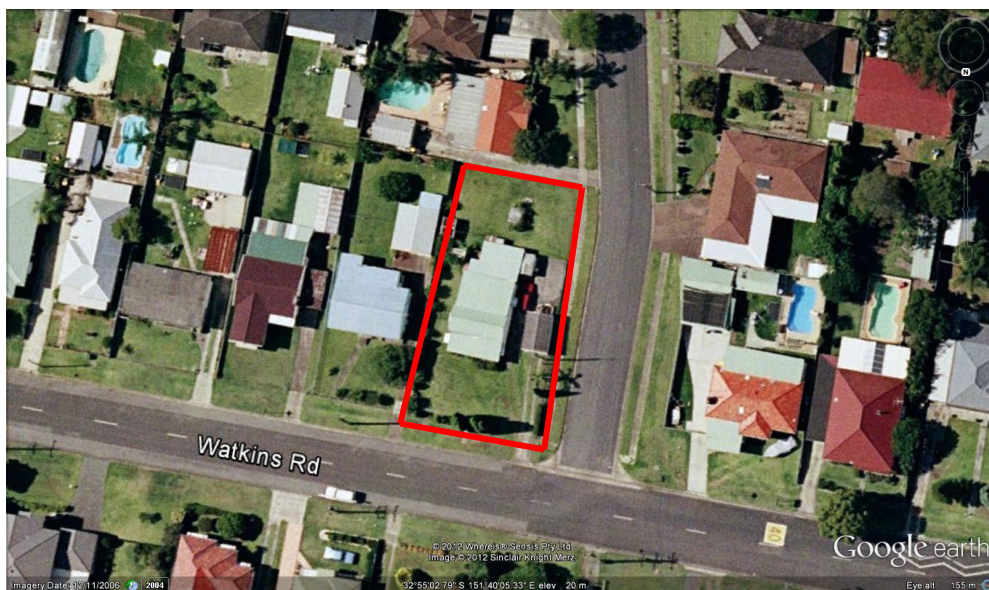
#### **Photo 1 Development site**

The site is boarded by existing residential properties to the south and east and by street frontage to the north and west (Photo1) (Site Plan appendix 4).

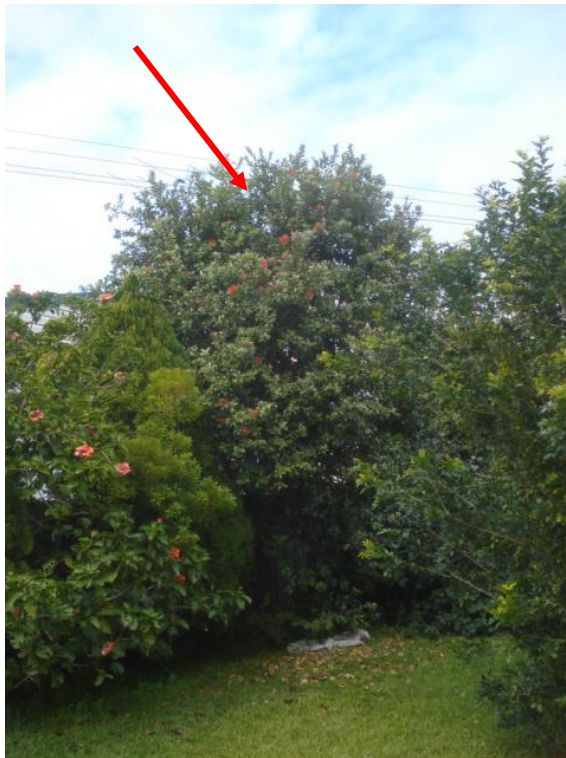
**Tree No. 3** displays good health and vigour however the tree is in poor structural condition due to past lopping techniques. This has resulted in multi stemmed epicormic shoots arising from where lopping cuts have been made.

Whilst foliage size appears to be normal crown density, growth extension and habit is considered to be abnormal as a result of epicormic re-growth.

Based on the Site Plan and Bulk Earthworks Plan **tree nos. 3 & 5** are within the footprint of the proposed buildings and / or where earthworks to cut soil are proposed and would require removal to facilitate the development.

Due to their small live crown size and /or relatively poor structure these trees are considered to have low retention values and can be replaced within the short term with new planting. Their removal will not significantly diminish from the nature of the area (Photo 2 & 3).

**Photo 2**  
**Tree no. 3 within footprint of proposed development**

### 1. Removal of Tree Nos. 3, 4, 5, 6 & 7

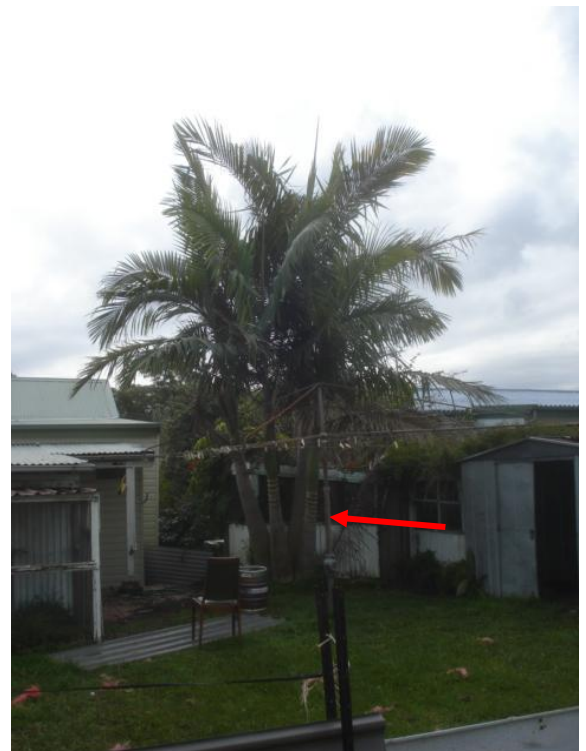
**Photo 3**  
**Tree no. 5 within footprint of proposed development**

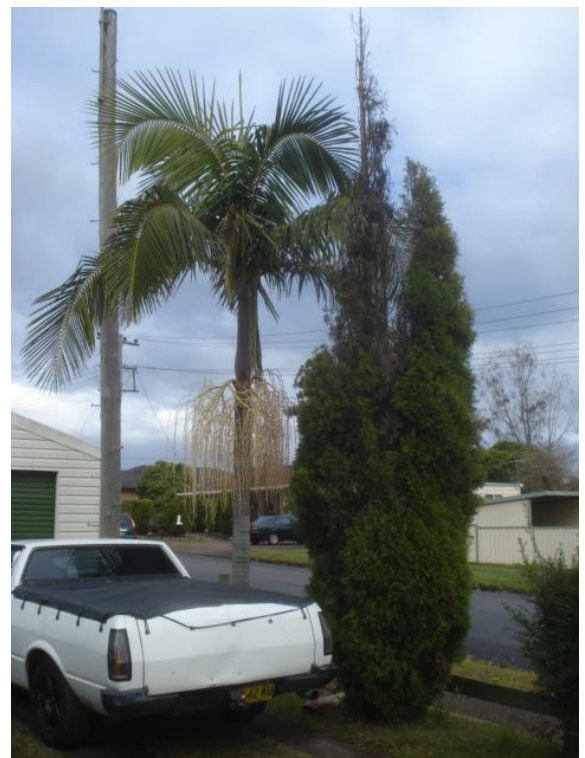
Plans show that earthworks require soil fill of 600mm to be made that will encompass the root zone of these trees.

Soil build-up and construction over the root system is considered to have a detrimental effect on their health and vitality and in the long term can result in their decline and eventually their death.

Due to its small live crown size and /or relatively poor structure these tree no.6 is considered to have low retention value and can be replaced within the short term with new planting.

The removal of these trees will not significantly diminish from the nature of the area (Photo 4).

**Photo 4**  
Soil to be placed over root zone of trees  
Low landscape and retention value

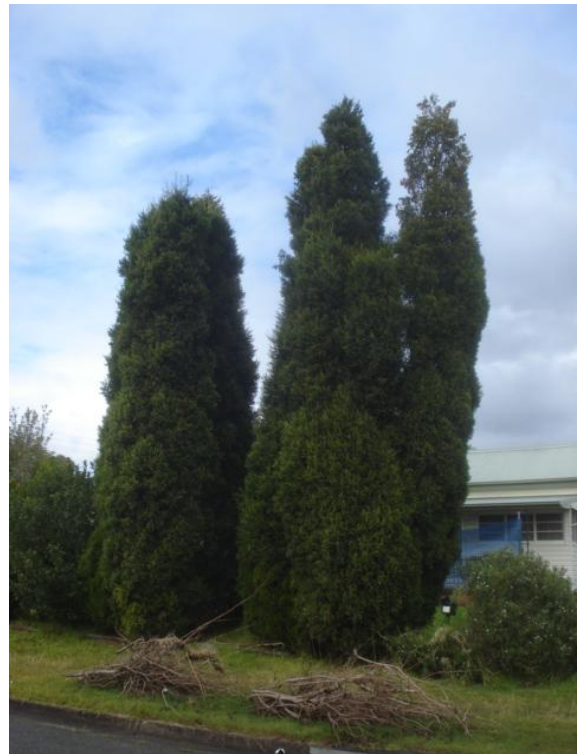
Based on the calculated TPZ's required for these trees construction activity will not significantly encroach within the required Tree Protection Zones.

Based on the proposed plans encroachment is expected to be minor and should be tolerated by these trees. Encroachment into the TPZ is expected to be less than less than 10%, outside their Structural Root Zone and the area lost to encroachment can be compensated for elsewhere and contiguous with the TPZ.

Due to their small live crown sizes they are considered to have low retention values and can be replaced within the short term with new planting. The removal of these trees will not significantly diminish from the nature of the area (Photo 5).

**Photo 5**  
**Tree nos. 1 & 2 not significantly impacted upon by construction however removal is preferred and will allow for replanting with more suitable species.**

### 2. Removal of Tree Nos. 1 & 2

The trees are located within the proposed landscaped area and although they are not expected to be significantly impacted upon by the development their removal is preferred and will allow for re-planting with more suitable species that would be more sustainable over the long term.
