Slope & Stability Report

Three Two Story Units
On A Vacant Block

Council: Newcastle City Council

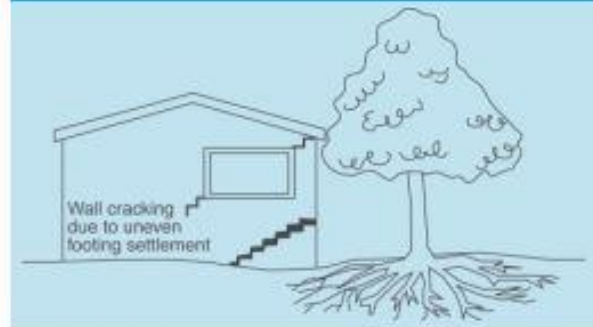
Trees can cause shrinkage and damage

As the weather pattern changes and the soil begins to dry out, the external footings will be first affected, beginning with the locations where the sun's effect is strongest. This has the effect of lowering the external footings. The doming is accentuated and cracking reduces or disappears where it occurred because of dishing, but other cracks open up. The roof lines may become convex.
